[Docket No. FAA-2022-0459; Project Identifier MCAI-2021-00266-E; Amendment 39-22102; AD 2022-13-16]

Airworthiness Directives; GE Aviation Czech s.r.o. (Type Certificate Previously held by WALTER Engines a.s., Walter a.s., and MOTORLET a.s.) Turboprop Engines

ACTION: Final rule.

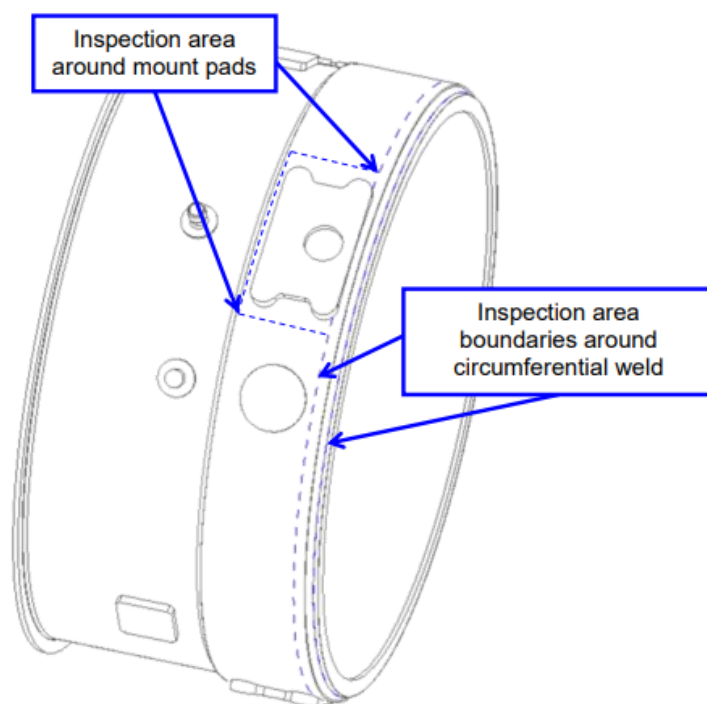
Figure 1. Centrifugal Compressor Case

This AD was prompted by the manufacturer revising the airworthiness limitations section (ALS) of the existing engine maintenance manual (EMM) to include a visual inspection of the centrifugal compressor case for cracks. The FAA is issuing this AD to prevent failure of the centrifugal compressor case. The unsafe condition, if not addressed, could result in failure of the centrifugal compressor case, engine separation, and loss of the airplane.

Do a visual inspection of the compressor case in the specified areas, shown in Figure 1, for every 100 ± 10 Flight Hours. Use magnifying lens 10x for inspection. No visible cracks are allowed.

(1) Within 90 days after the effective date of this AD, revise the ALS of the existing EMM by incorporating Figure 1 to paragraph (g)(1) of this AD.
